# The Panasonic K Deck

It's three years since Panasonic VCRs started to use the K deck, long enough for a service history to be prepared. **John Coombes** describes the various fault conditions he has encountered

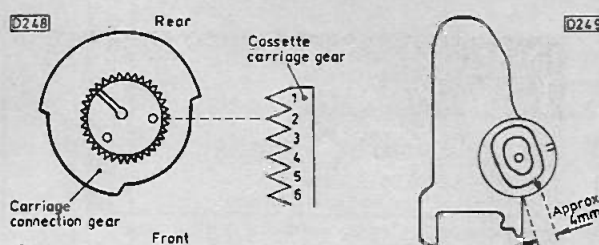
**Fig. 1 (left): Carriage connection gear phase alignment.**

If the cassette blinder flap doesn't close, check the operation of the carriage connection gear with the side plate unit (right-hand side). There may be a phase error between the two assemblies. Remove the cassette unit and ensure that the tape will go in and out of the housing freely by hand. If this is OK, set up the carriage connection gear as laid down in the service manual. If the two side plate units and the carriage connection gear are incorrectly set, the tape may be ejected immediately after it's inserted. For smooth loading and unloading, the carriage connection gear must be set up to fit into the cassette carriage gear as shown in Fig. 1.

Note that if eject is selected when the cassette carriage is not in position, when it's refitted the main cam gear will not engage with the carriage connection gear which will not rotate. To reset, rotate the carriage connection gear by hand so that, as shown in Fig. 1, it's in alignment with the cassette carriage gear.

For correct operation of all mechanical functions the mode switch must be set correctly. Set it as shown in Fig. 2, in the eject mode, so that there is a 4mm gap between the edge of the switch and the arrow marked on the dial.
