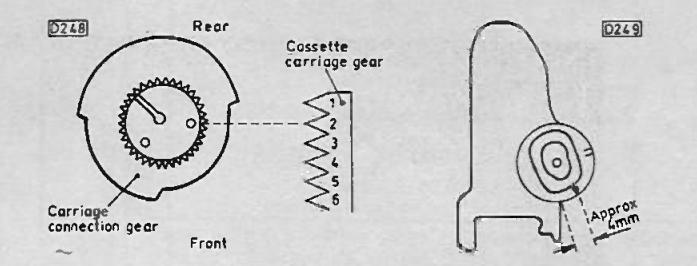
Fig. 1 (left): Carriage connection gear phase alignment.

If the cassette blinder flap doesn't close, check the operation of the carriage connection gear with the side plate unit (right-hand side). There may be a phase error between the two assemblies. Remove the cassette unit and ensure that the tape will go in and out of the housing freely by hand. If this is OK, set up the carriage connection gear as laid down in the service manual. If the two side plate units and the carriage connection gear are incorrectly set, the tape may be ejected immediately after it's inserted. For smooth loading and unloading, the carriage connection gear as shown in Fig. 1.

For correct operation of all mechanical functions the mode switch must be set correctly. Set it as shown in Fig. 2, in the eject mode, so that there is a 4mm gap between the edge of the switch and the arrow marked on the dial.

Note that if eject is selected when the cassette carriage is not in position, when it's refitted the main cam gear will not engage with the carriage connection gear which will not rotate. To reset, rotate the carriage connection gear by hand so that, as shown in Fig. 1, it's in alignment with the cassette carriage gear.
